## Native Vegetation Clearance

### Whyalla Airport – Asphalt Plant Compound

## Data Report

Clearance under Section 28 of the *Native Vegetation Act 1991*

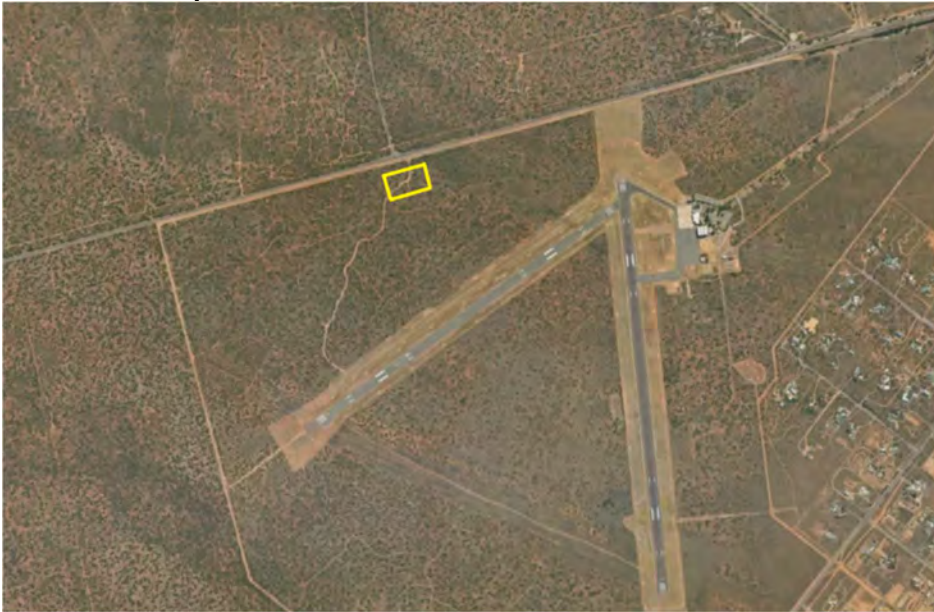
*Area of clearance shown above as the yellow rectangle*

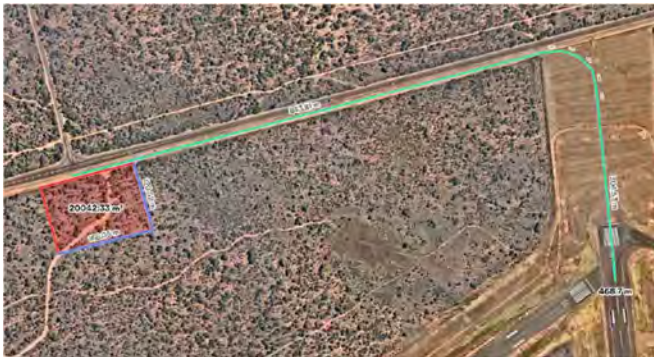
The traffic flow diagram, pictured below, shows that all reasonable steps have been taken to minimize the impact on vegetation. Furthermore, the layout strategically minimises the need for additional clearance, while addressing the critical requirements for the airport upgrade.

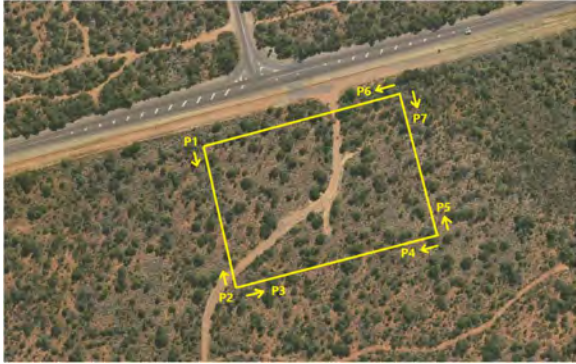
<i>Map showing location and direction of photo points</i>

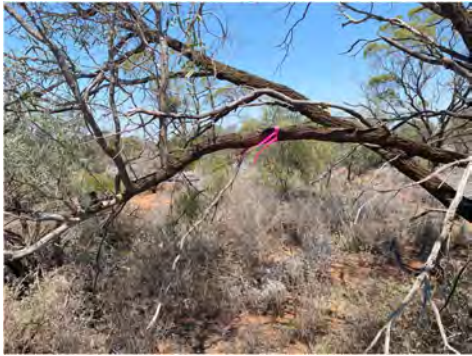
<i>P1</i>

Vegetation Association	Acacia papyrocarpa Myoporum platycarpum Open Woodland over mixed shrub Understory
Representative photos

General description	Dominant species include <i>Acacia papyrocarpa</i> (Western Myall), <i>Alectryon oleifolius</i> (Bullock Bush) <i>Myoporum platycarpum</i> (False Sandalwood) over <i>Geijera linearifolia</i> (Sheep bush) <i>Maireana sedifolia</i> (Pearl bluebush) and <i>Senna artemisioides</i> subsp. <i>coriacea</i> (Desert cassia) in good condition, particularly considering how dry the ground is at the moment, with so little rain recorded in recent months. There is little evidence of recent disturbance, except for areas closer to the tracks surrounding and running through the area, that is proposed to be cleared.				
Threatened species or community	Graham Carpenter (DEW) highlighting that this area provides habitat for the Southern Whiteface ( <i>Aphelocephala leucopsis</i> ) – EPBC vulnerable; Gilbert's Whistler ( <i>Pachycephala incornata</i> ) – SA rare; Major Mitchell's (Pink) Cockatoo ( <i>Lophochroa leadbeateri</i> )-SA rare; as species listed under the EPBC Act or NP&W Act.

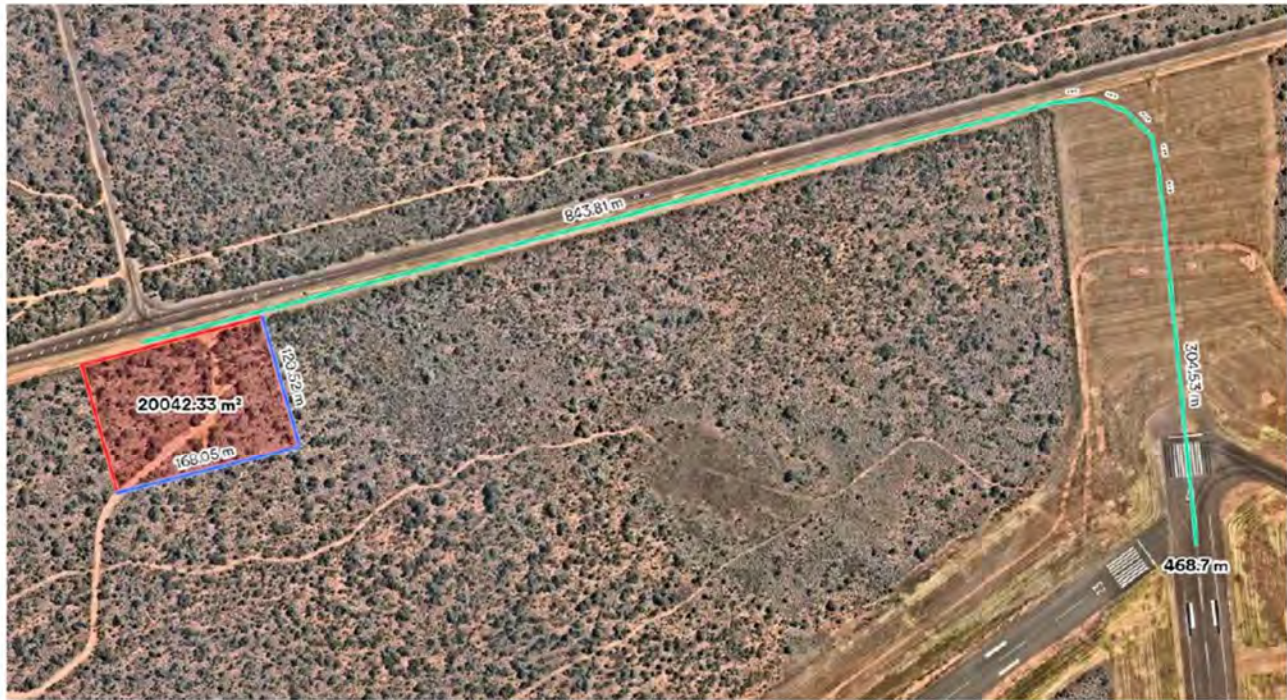
#### OVERALL LAYOUT

Please note that the picture below doesn't show the 30m setback of clearance into the native vegetation, to screen the asphalt plant compound from view from Lincoln Highway and Jenkins Avenue, as well as to provide a wider strip of vegetation for the native wildlife to safely pass to the north of the compound.

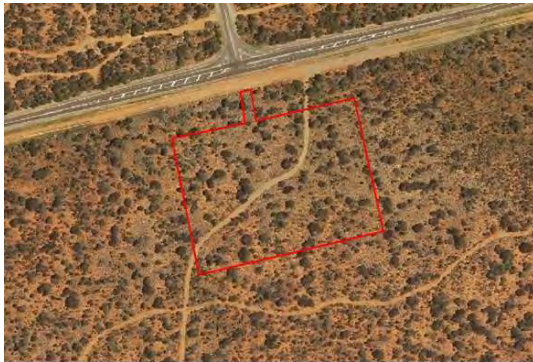
Where avoidance was not possible, measures have been taken to minimise the impact on native vegetation. The location for the proposed clearance has been selected / positioned in an area close to Jenkins Avenue, in consultation with DIT, where B-Double trucks can easily access and egress to and from the site, with the temporary compound to essentially be fenced off and reclassified as landside of the airport. This will allow for the 24 hour operation of the asphalt plant, while also satisfying DIT and CASA requirements. The location of the compound has also been moved 30m south, creating a 30m buffer from the airport perimeter track, retaining some of the better patches of Western Myall trees, while also providing a wider strip of vegetation for native fauna to pass to the north of the compound.
